Use of Non-destructive Techniques to Detect Damage Induced by Corrosion of Pre-stressing Steel Strands

Josef STRYK¹, Monika MANYCHOVÁ², Marta KOŘENSKÁ¹, Aleš FRÝBORT¹,
Václav SVOBODA³

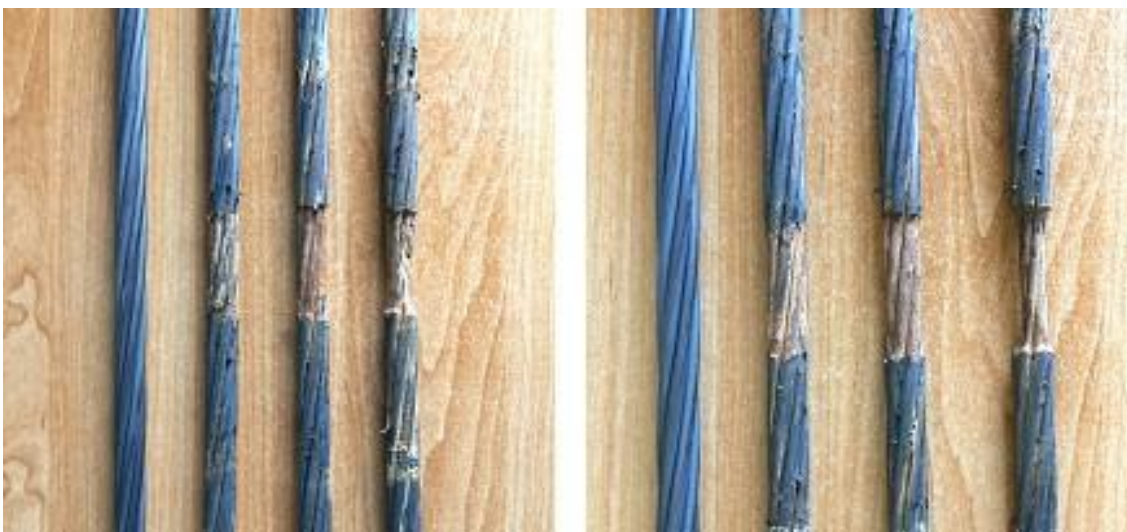
The corroded strands were measured by non-linear ultrasonic spectroscopy in CDV laboratories and after that had drive transport to Preditest company for MMM measurement and tensile testing. The visual condition of all measured strands is documented in Fig. 2. The strands are sorted according to the increasing duration of the corrosion process: L90 to L912; L100 to L1012.

Figure 2. Two groups of measured strands: on the left L9 group; on the right L10 group

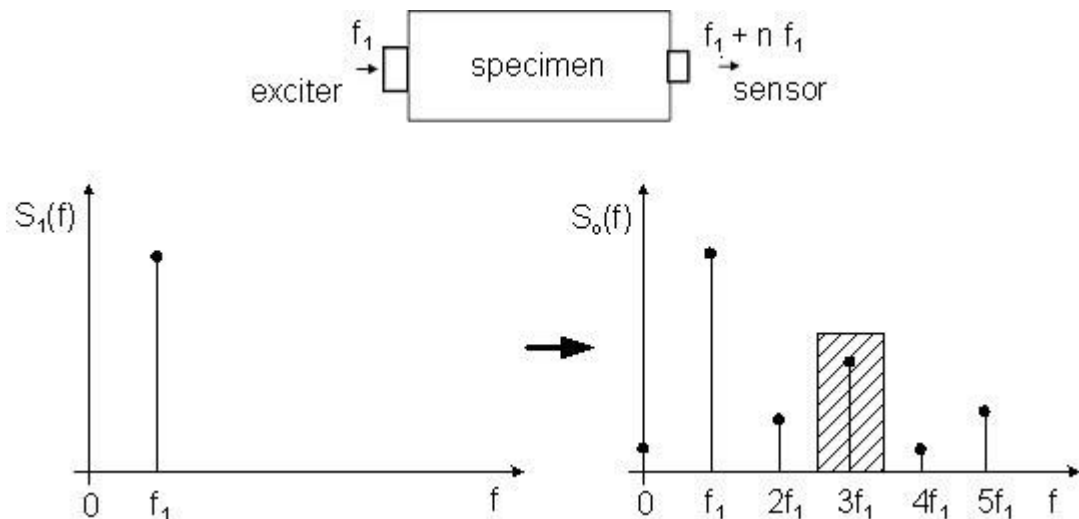
In general, these frequency component amplitudes are falling when the harmonic order natural number, n , is increasing. If the nonlinearity effect is not entirely symmetrical, there can arise low-amplitude second and higher even-numbered harmonic components, whose amplitudes may be lower than those of the odd-numbered ones. Among these emerging components, the third harmonic is the most distinctive one, see Fig. 3. Therefore, its amplitude is pursued most frequently [3].

Figure 3. Frequency spectrum of a nonlinear medium response

frequency spectrum of the received signal, which may allow direct observation of the higher harmonic generation or intermodulation distortion features, see Fig. 3. In second place the nonlinearity parameter can be derived from the amplitudes of the fundamental and harmonic frequencies. Assuming that changes in the wave propagation velocity and the attenuation are small, and in experimental conditions like those used in this work (nonlinear measurements done with an input signal of fixed frequency, and the transducers located always at the same positions), the parameter of nonlinearity can be approximated as: $Bpn = A_3 / A_1^3$, being A_1 amplitudes of the fundamental and A_3 third harmonic waves [4]. In practice, the variation of these ratios relative to the initial undamaged conditions is used as an indicator of the microstructural damage [5].

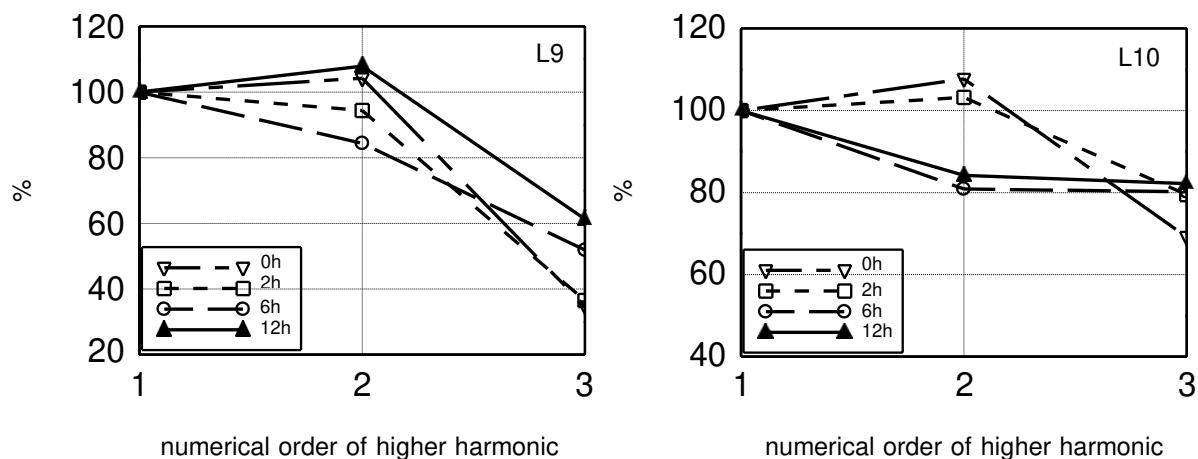
Measuring results from the first strategy are represented by the following Fig. 4 showing the values of higher harmonic frequency amplitudes as a percentage of the 1st harmonic (exciting frequency f_1) amplitude for both groups.

Figure 4. Higher harmonic frequency amplitudes expressed as a percentage of the first harmonic amplitude; on the left - group L9, on the right - group L10

It is apparent from Fig. 4 that the amplitudes of the third harmonics (A_3) are always lower than the fundamental amplitude (A_1) in all frequency spectra. Anomalies are evident in some spectra; the second harmonic amplitude (A_2) exceeded the fundamental amplitude in the case of non-corroded strands L90 and L100, strand L912 (after 12 hours of corrosion process action) and strands L102 (after 2 hours of corrosion process action). The consequences of corrosion manifested by a growing in the amplitude values of the third harmonics after 6 and 12 hours of corrosion action, as can be seen in both graphs in Fig. 4. This observation point out to the possibility that nonlinear ultrasonic measurements may provide an early warning of the damage due to strand corrosion.

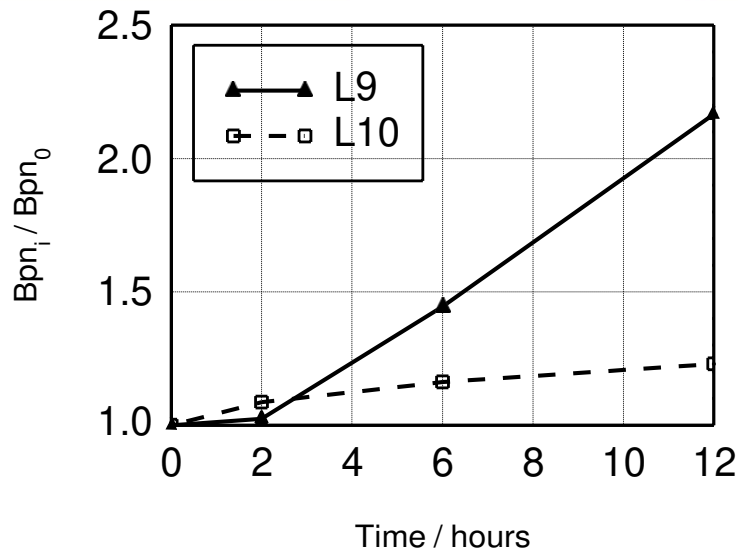
Figure 5 shows the variations of the relative values of the parameter Bpn from tests of strands which were subjected corrosion process for differed time (0, 2, 6 and 12 hours). Any value in the figure is normalized to its corresponding value at zero time (0 hours). A linear increase in the value of this parameter is evident from 2 hours of the corrosion process. It must be recalled that the values of this Bpn parameter is proportional to those of the rigorously defined nonlinearity parameters, Sect. 2.1. Previously it was proposed a tenfold increase relative to the initial values of these parameters, as the arbitrary threshold for considering a critical increase of the nonlinear elastic features, which in turn would be indicative of the presence of significant defects or damage in the material medium [6].

Figure 5. Evolution of the parameter Bpn normalized to this initial values (at the time = 0 hours)

Graph shows the variations of the relative values of the parameter dHy/dx from tests of strands which were subjected corrosion process at differed time (0, 2, 6 and 12 hours). Values in the figure are normalized to its corresponding value at the time = 0 hours. A linear increase in the value of this parameter is evident from 2 hours of the corrosion process action, similarly as in the case of parameter Bpn in Fig. 5.

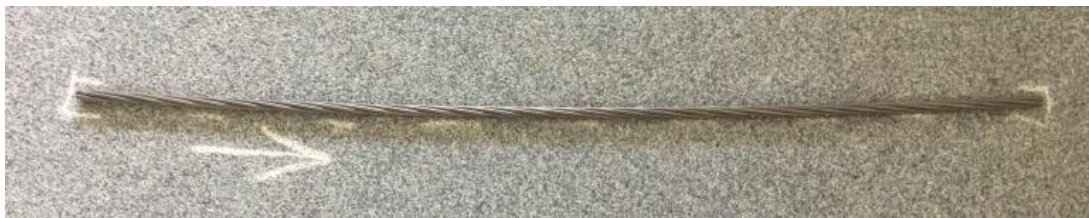
The steel strands were arranged in the line on the ground, Fig. 7. The indicative contactless measurement was applied in the distance 100 mm from the surface of the strands.

Figure 7. Intact steel strand L90

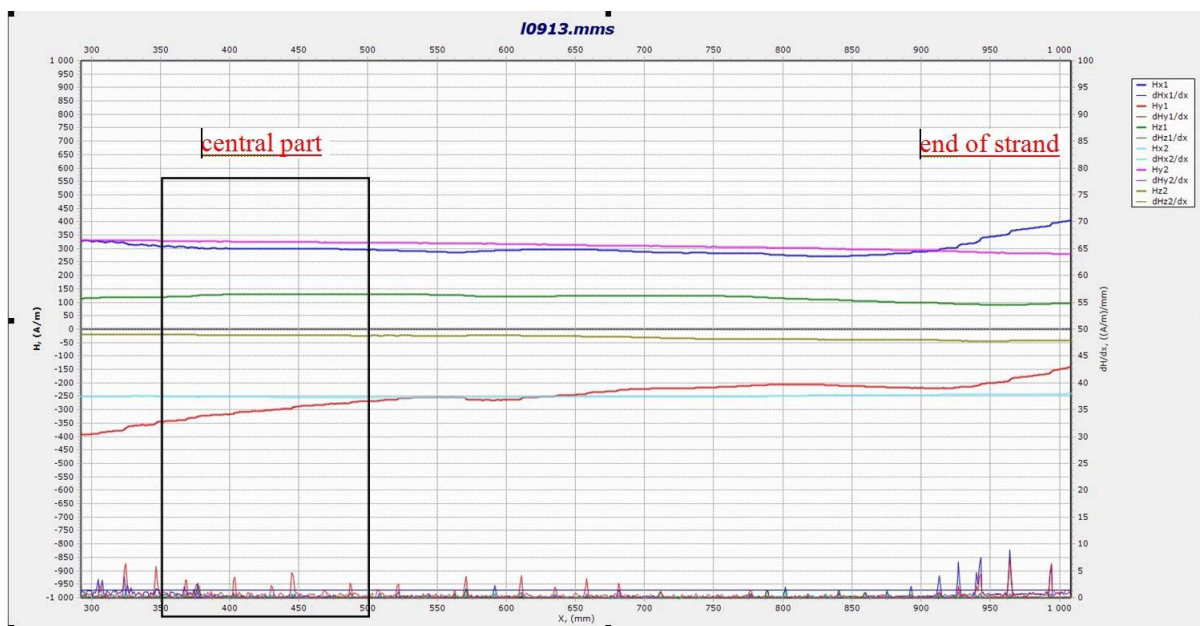
The measurement was repeated three times to verify the repeatability of the measurement results. The measurement results are presented here in the form of the magnetograms from measurements of group L9. Black rectangle indicated in magnetograms corresponds to evaluated strand central part subjected to corrosion process. A magnetogram in Fig. 8 illustrates the results of the continuous scanning of intact (uncorroded) strand L90.

Figure 8. Magnetogram 10913.mms corresponds to undamaged steel strand L90

The magnetogram shows graphically the field strength H_y and the field gradient dH_y/dx as a function of the distance L_x . The uniform distribution of the field strength H_y in the magnetogram confirms that the structure of the strand is uniform throughout its length.

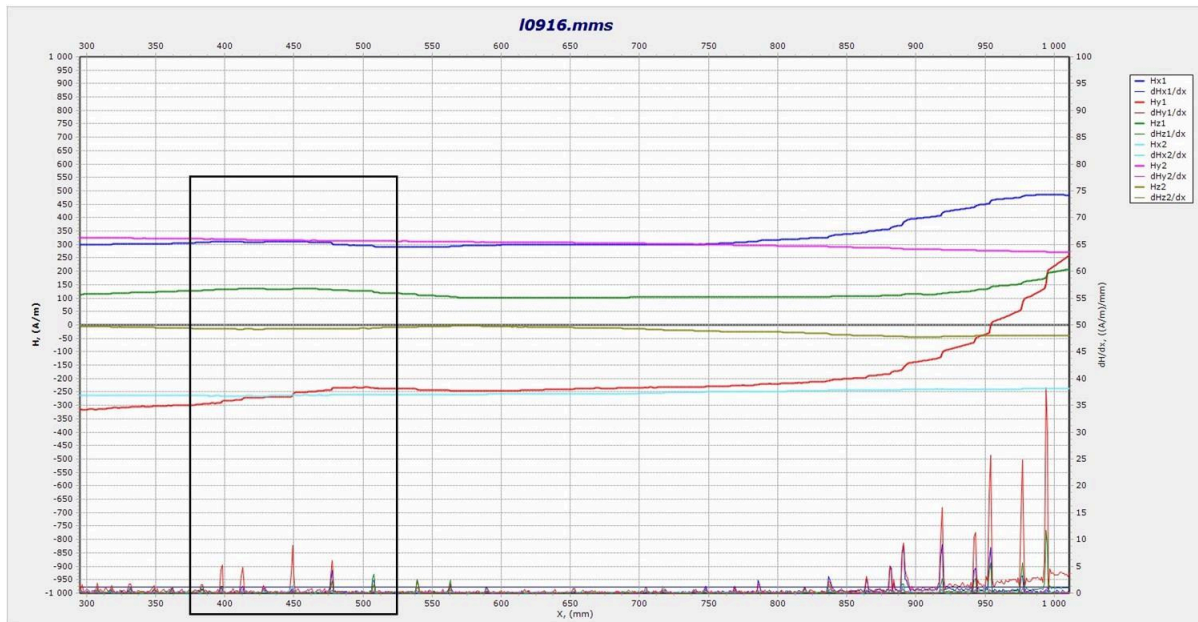
Fig. 9 presents the magnetogram from scanning the strand L92 after 2 hours of corrosion process. The magnetogram shows zone of slight increased stress concentration of field strength in the range of coordinates x , correspond to corroded part of strand L92. Max value of the field gradient dH_y/dx amounts to 9.0 (A/m)/mm.

Figure 9. Magnetogram 10916.mms correspond to strand L92 – after 2 hours of corrosion process

Next Fig. 10 presents the results of the continuous scanning of strand L96, after 6 hours of corrosion process. In the magnetogram is evident further increased stress concentration of field strength in comparison with magnetogram in Fig. 9. Max value of the field gradient dH_y/dx amounts to 43.0 (A/m)/mm.

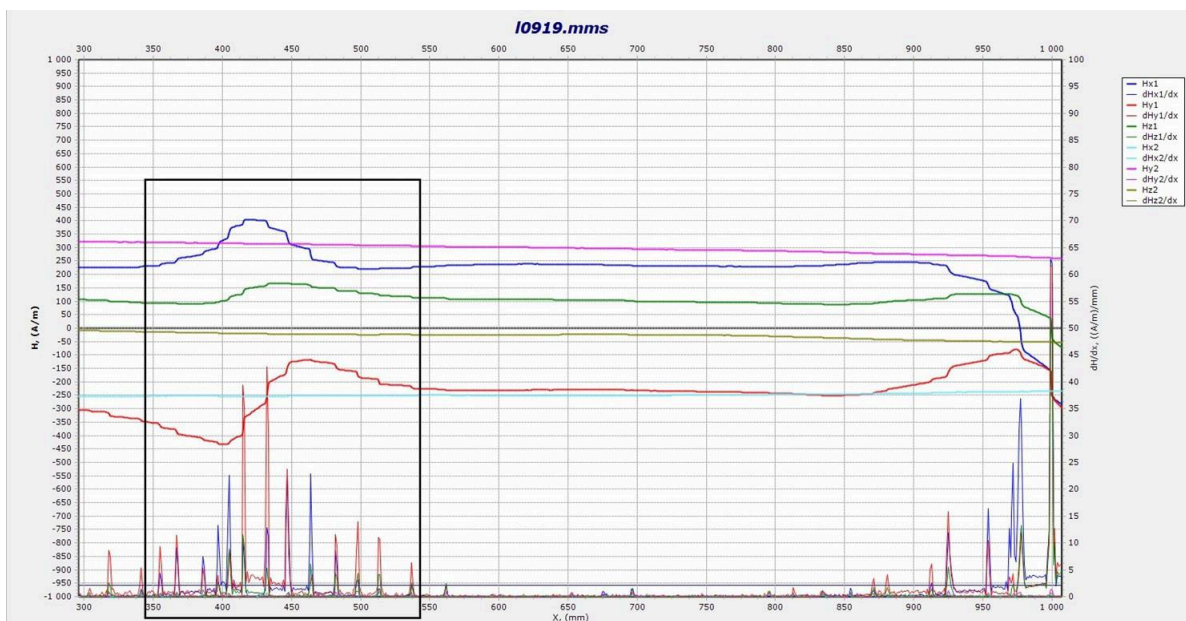
Figure 10. Magnetogram 109169.mms correspond to strand L96 – after 6 hours of corrosion process

Fig 11 presents measurement results of strand L912 after 12 hours of corrosion process. The magnetogram shows higher value of the field gradient dHy/dx in comparison with strand L96. It amounts to 100.0 (A/m)/mm.

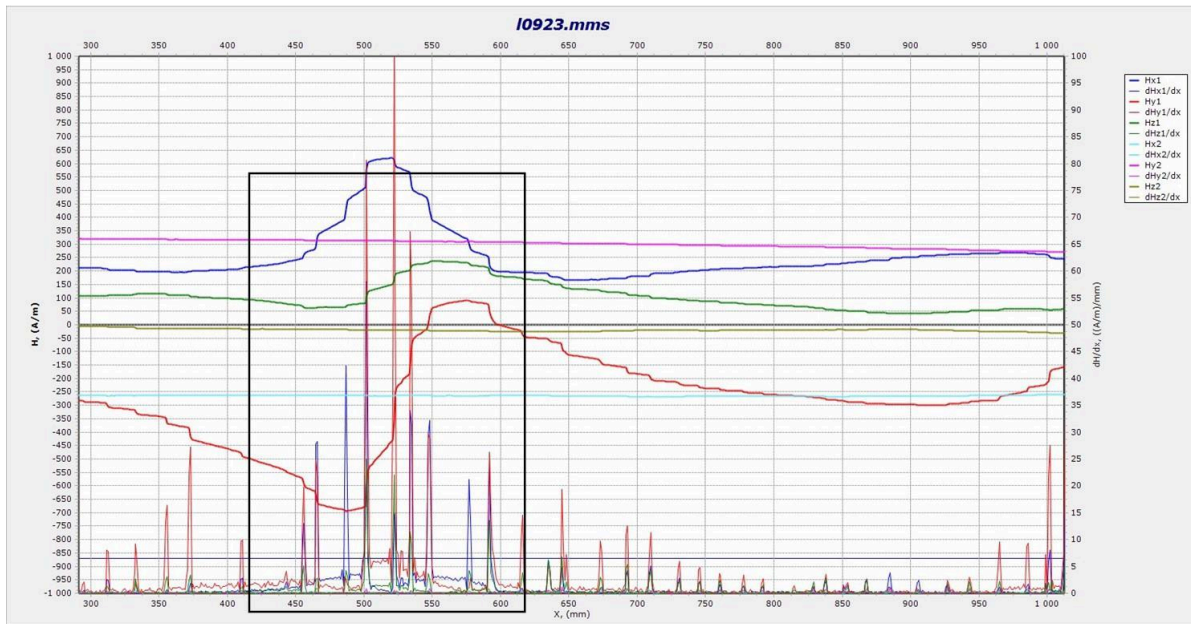
Figure 11. Magnetogram 10923.mms correspond to strand L912 – after 12 hours of corrosion process

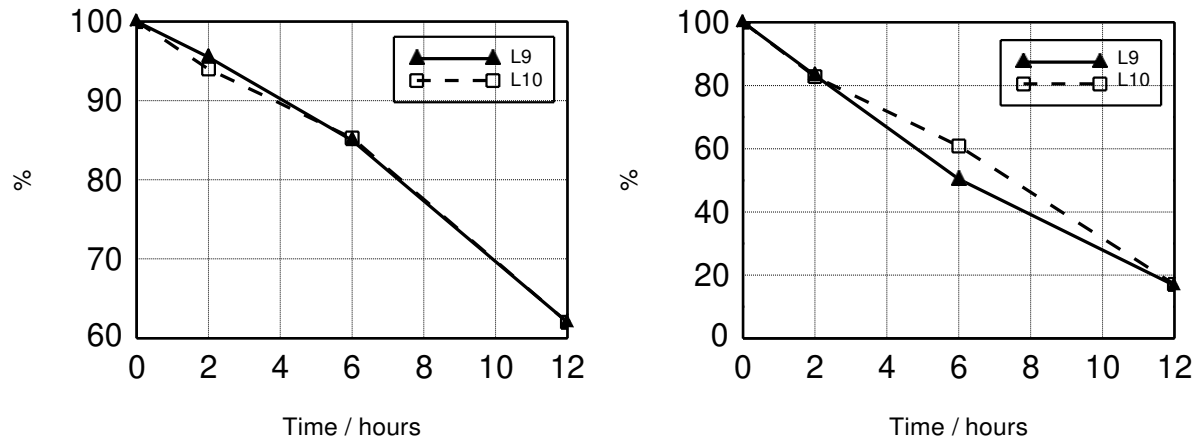
Finally the tested strands were subjected to tensile strength tests in order to determine their mechanical properties and verify and complement measurement results. Appraising parameters of strand damage were following: normalized values of strand diameters in affected area and force F_{max} corresponding to failure of strands during the tests. These parameters are compared graphically in Fig. 13.

Figure 13. Consequences of corrosion on strands: on the left - normalized values of strand diameters; on the right - normalized values of force F_{max} corresponding to failure of strands during tensile strength tests

Both graphs show a deterioration of mechanical properties of corroded strands. The normalized values of the parameters (strand diameter and breaking force F_{max}) show a linear decrease with increasing time of subjecting the steel strands to the corrosion process.
